-	FIRING CUTOUT INTERFERENCE ELIMIN MARK 75 GUN ON BOARD USS PEGASUS		Final rept
+	7. AUTHOR(a)		S. CONTRACT OF STANT HUMBER(s)
	K. E. Norman		(2) 39p.
•	Naval Surface Weapons Center Dahlgren Laboratory (N32) Dahlgren, Virginia 22448	(	10. PROGRAM ELEMENT, PROJECT, TA
1	1. CONTROLLING OFFICE NAME AND ADDRESS		DOCUMENT ONTE
	Naval Sea Systems Command Washington, D.C. 20362	U	December 1978
1	4. MONITORING AGENCY NAME & ADDRESS(II different	t from Controlling Offic	e) 15. SECURITY CLASS. (of this report)
+			UNCLASSIFIED
	Karl E./Norman, H. A./Newton W. H./Hammer		15a. DECLASSIFICATION/DOWNGRADIN
	Approved for public release; dist	ribution unlin	nited.

#### FOREWORD

# SAFETY ANALYSIS OF AN INTERFERENCE ELIMINATOR FOR THE MARK 75 GUN MOUNT ON THE PHM 1

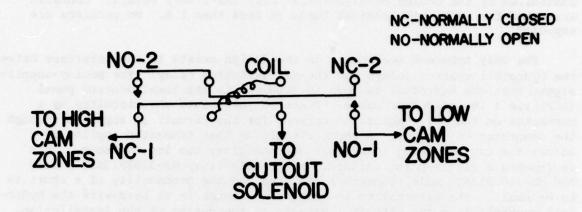
Figure C-3. Relay Contacts

Figure C-3 shows the position of the cam switching relay in the deenergized position, with the high cam zone activated. If contact NC-1 fails in the closed position, the high cam zone ie engaged regardless of the position of the hydrofoil. This represents what might be termed a reliability failure.

When the hydrofoil goes down, the coil energizes, contact NC-1 switches to NO-2, and NC-2 switches to NO-1. This engages the low cam zones. If NO-2 fails closed when the hydrofoil returns to the raised position, the whole cam control circuit is deactivated and the gun will not fire. The relay has to be replaced to activate the cutout system.

If NO-2 fails in the closed position, a much more serious situation exists. The low cam zone is partially activated, regardless of the hydrofoil position. The relay appears to function normally; however, only one additional failure, that of NO-1 failing closed, is necessary to permanently engage the low cam zone. The gun can then be fired into the front hydrofoil when the hydrofoil is in the raised position.

Contact failures are felt to be a very low-probability event in this instance. The cam switching relay, manufactured by HI-G, Incorporated, is a high-reliability relay. Although it is not a military standard (MS)-qualified relay, much of the technology used in making military quality relays is used in its manufacture. The relay used is one normally existing as a spare relay in the 76-mm mount and is identical to others used in the MARK 75. Its 4-A contact rating and nominal 300-mA contact load in operation will eliminate all of the normal problems associated with contact failure. Hazards associated with contact failure are therefore felt to be controlled.

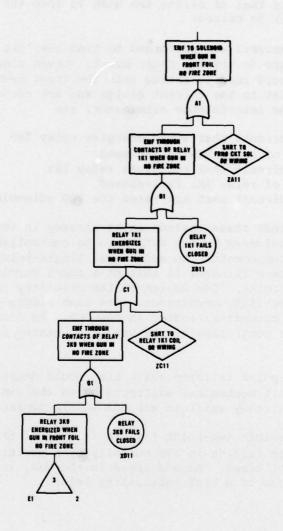
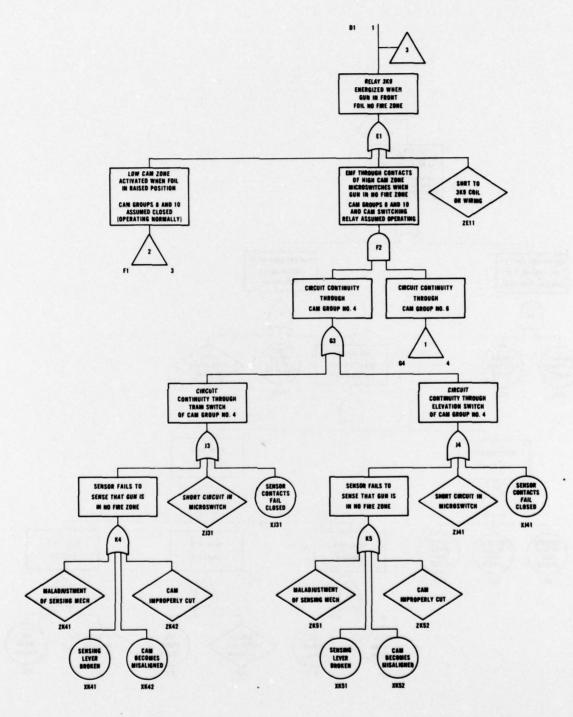
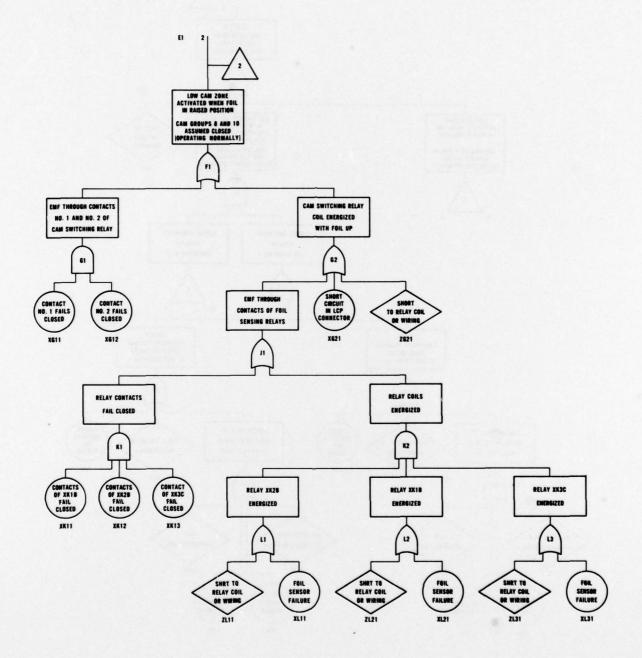
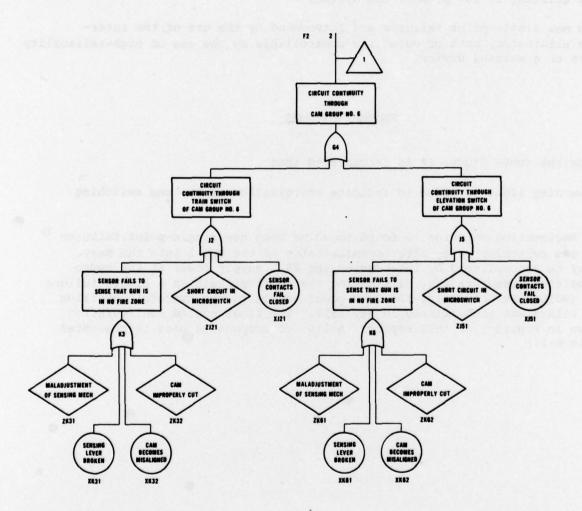
Figure C-5. Interference Eliminator Fault Tree Analysis (Sheet 1 of 4)

A computer analysis was performed to find the "cut sets" or shortest paths from a failure to the top fault event. Seven single-point failures were found that could lead to firing into the front hydrofoil. Five of these hazards, which exist in the current design and are not a function of the introduction of the interference eliminator, are

- 1. A short circuit that would energize relay 3K9
- 2. Contacts of relay 3K9 fail-closed
- 3. A short circuit that energizes relay 1Kl
- 4. Contacts of relay 1Kl fail-closed
- 5. A short circuit that activates the FCO solenoid

It is emphasized that these hazards exist already in the MARK 75 mount cam system and are considered by the WSESRB to be controllable by the use of high-reliability components. An additional single-point failure introduced by the interference eliminator is that of a short circuit that energizes the cam switching relay. The design of the circuitry is such that this should be a very low-probability occurrence. The last single-point failure is that of a short in the connector located in the LCP. As discussed in the PHA, this hazard can be controlled by the use of a warning light to indicate relay energization.

- 1. A warning light be added to indicate energization of the cam switching relay.
- 2. An engineering solution be found to solve both new single-point failures in the cam switching relay after commissioning of the PHM 1 into the Navy. This may be accomplished by introducing the 28 V supply power at the hydrofoil position sensor relays, eliminating the short circuit as a single failure mode. (NOTE: Relocation of the 28 V power source to the hydrofoil position sensor relays was accomplished in May 1978. The final system configuration is shown in Figure 1 of this report. A list of components used is presented in Table A-1.)
